EXCAVATION OF THE TIMBER CAUSEWAYED ROMAN ROAD AT SCAFTWORTH, nr. BAWTRY, NOTTS. 1991

INTERIM REPORT

By Martin J. Dearne

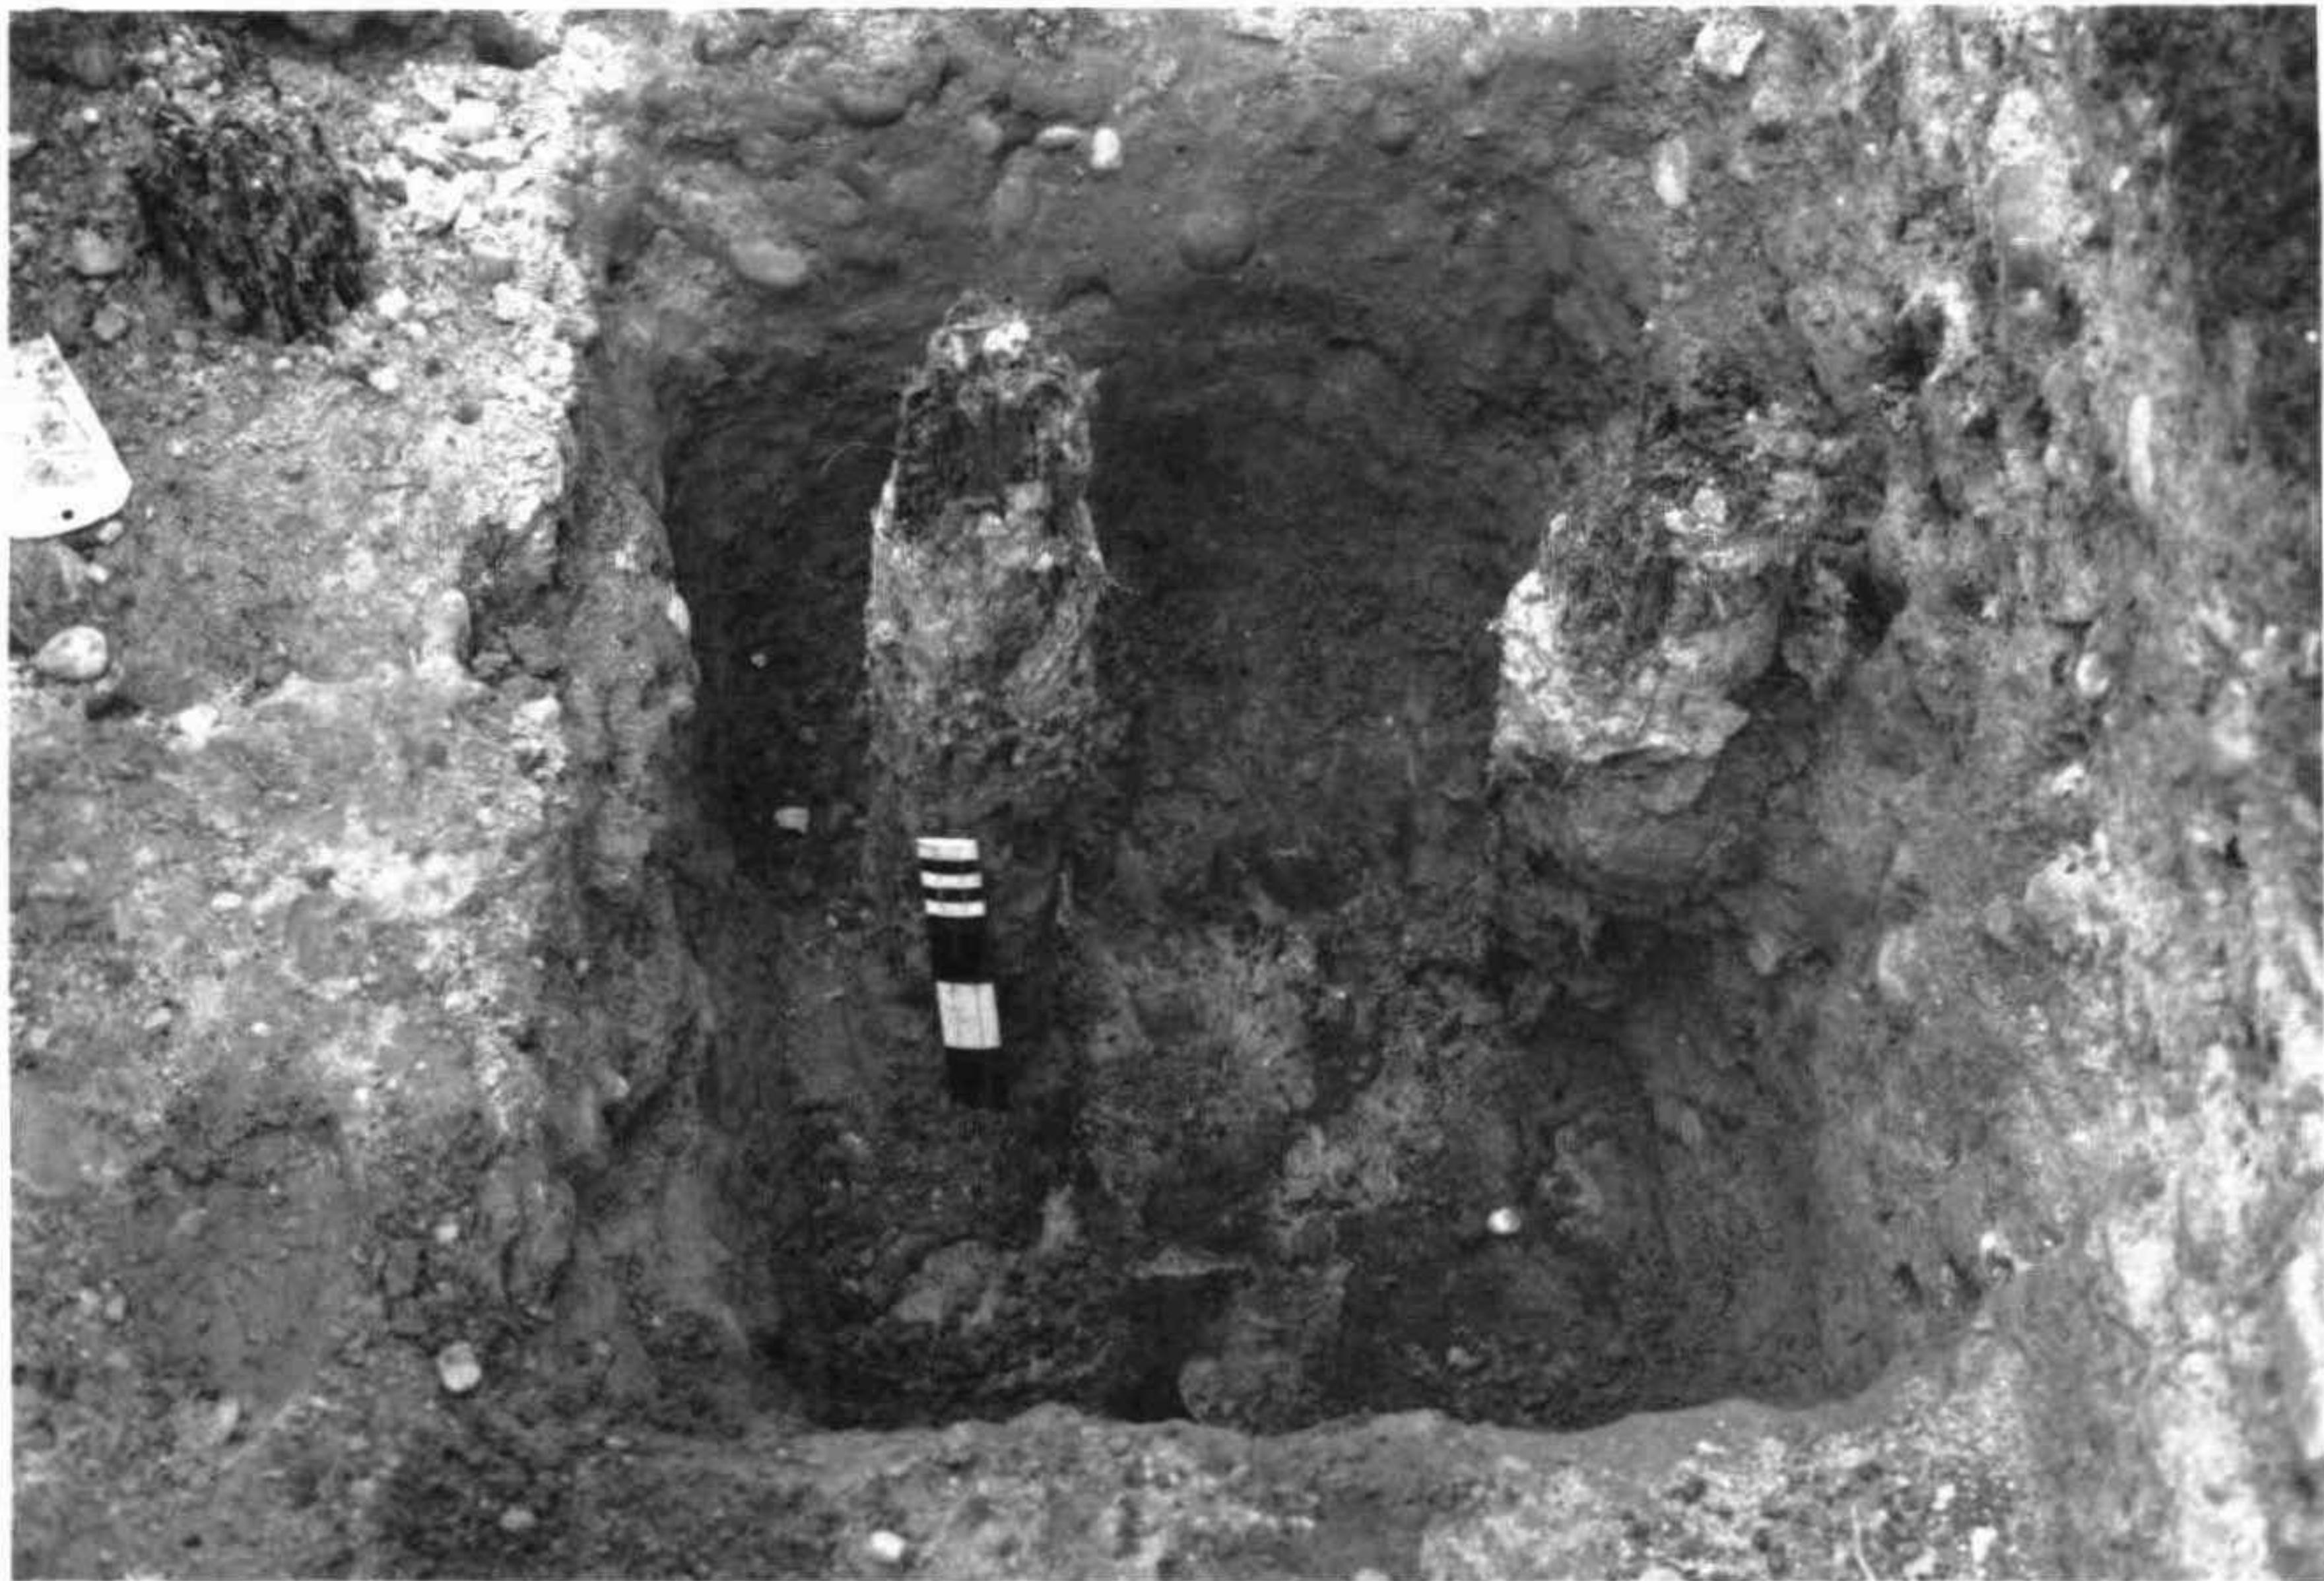
③

- 3 Stakes north of the timber raft penetrating the natural peat. Looking north. 20cm scale.
- 4 South half of the timber raft looking south. 1m scale.
- 5 North half of the timber raft showing the large stakes (after removal of the south half of the raft). Looking south. 1m scale.

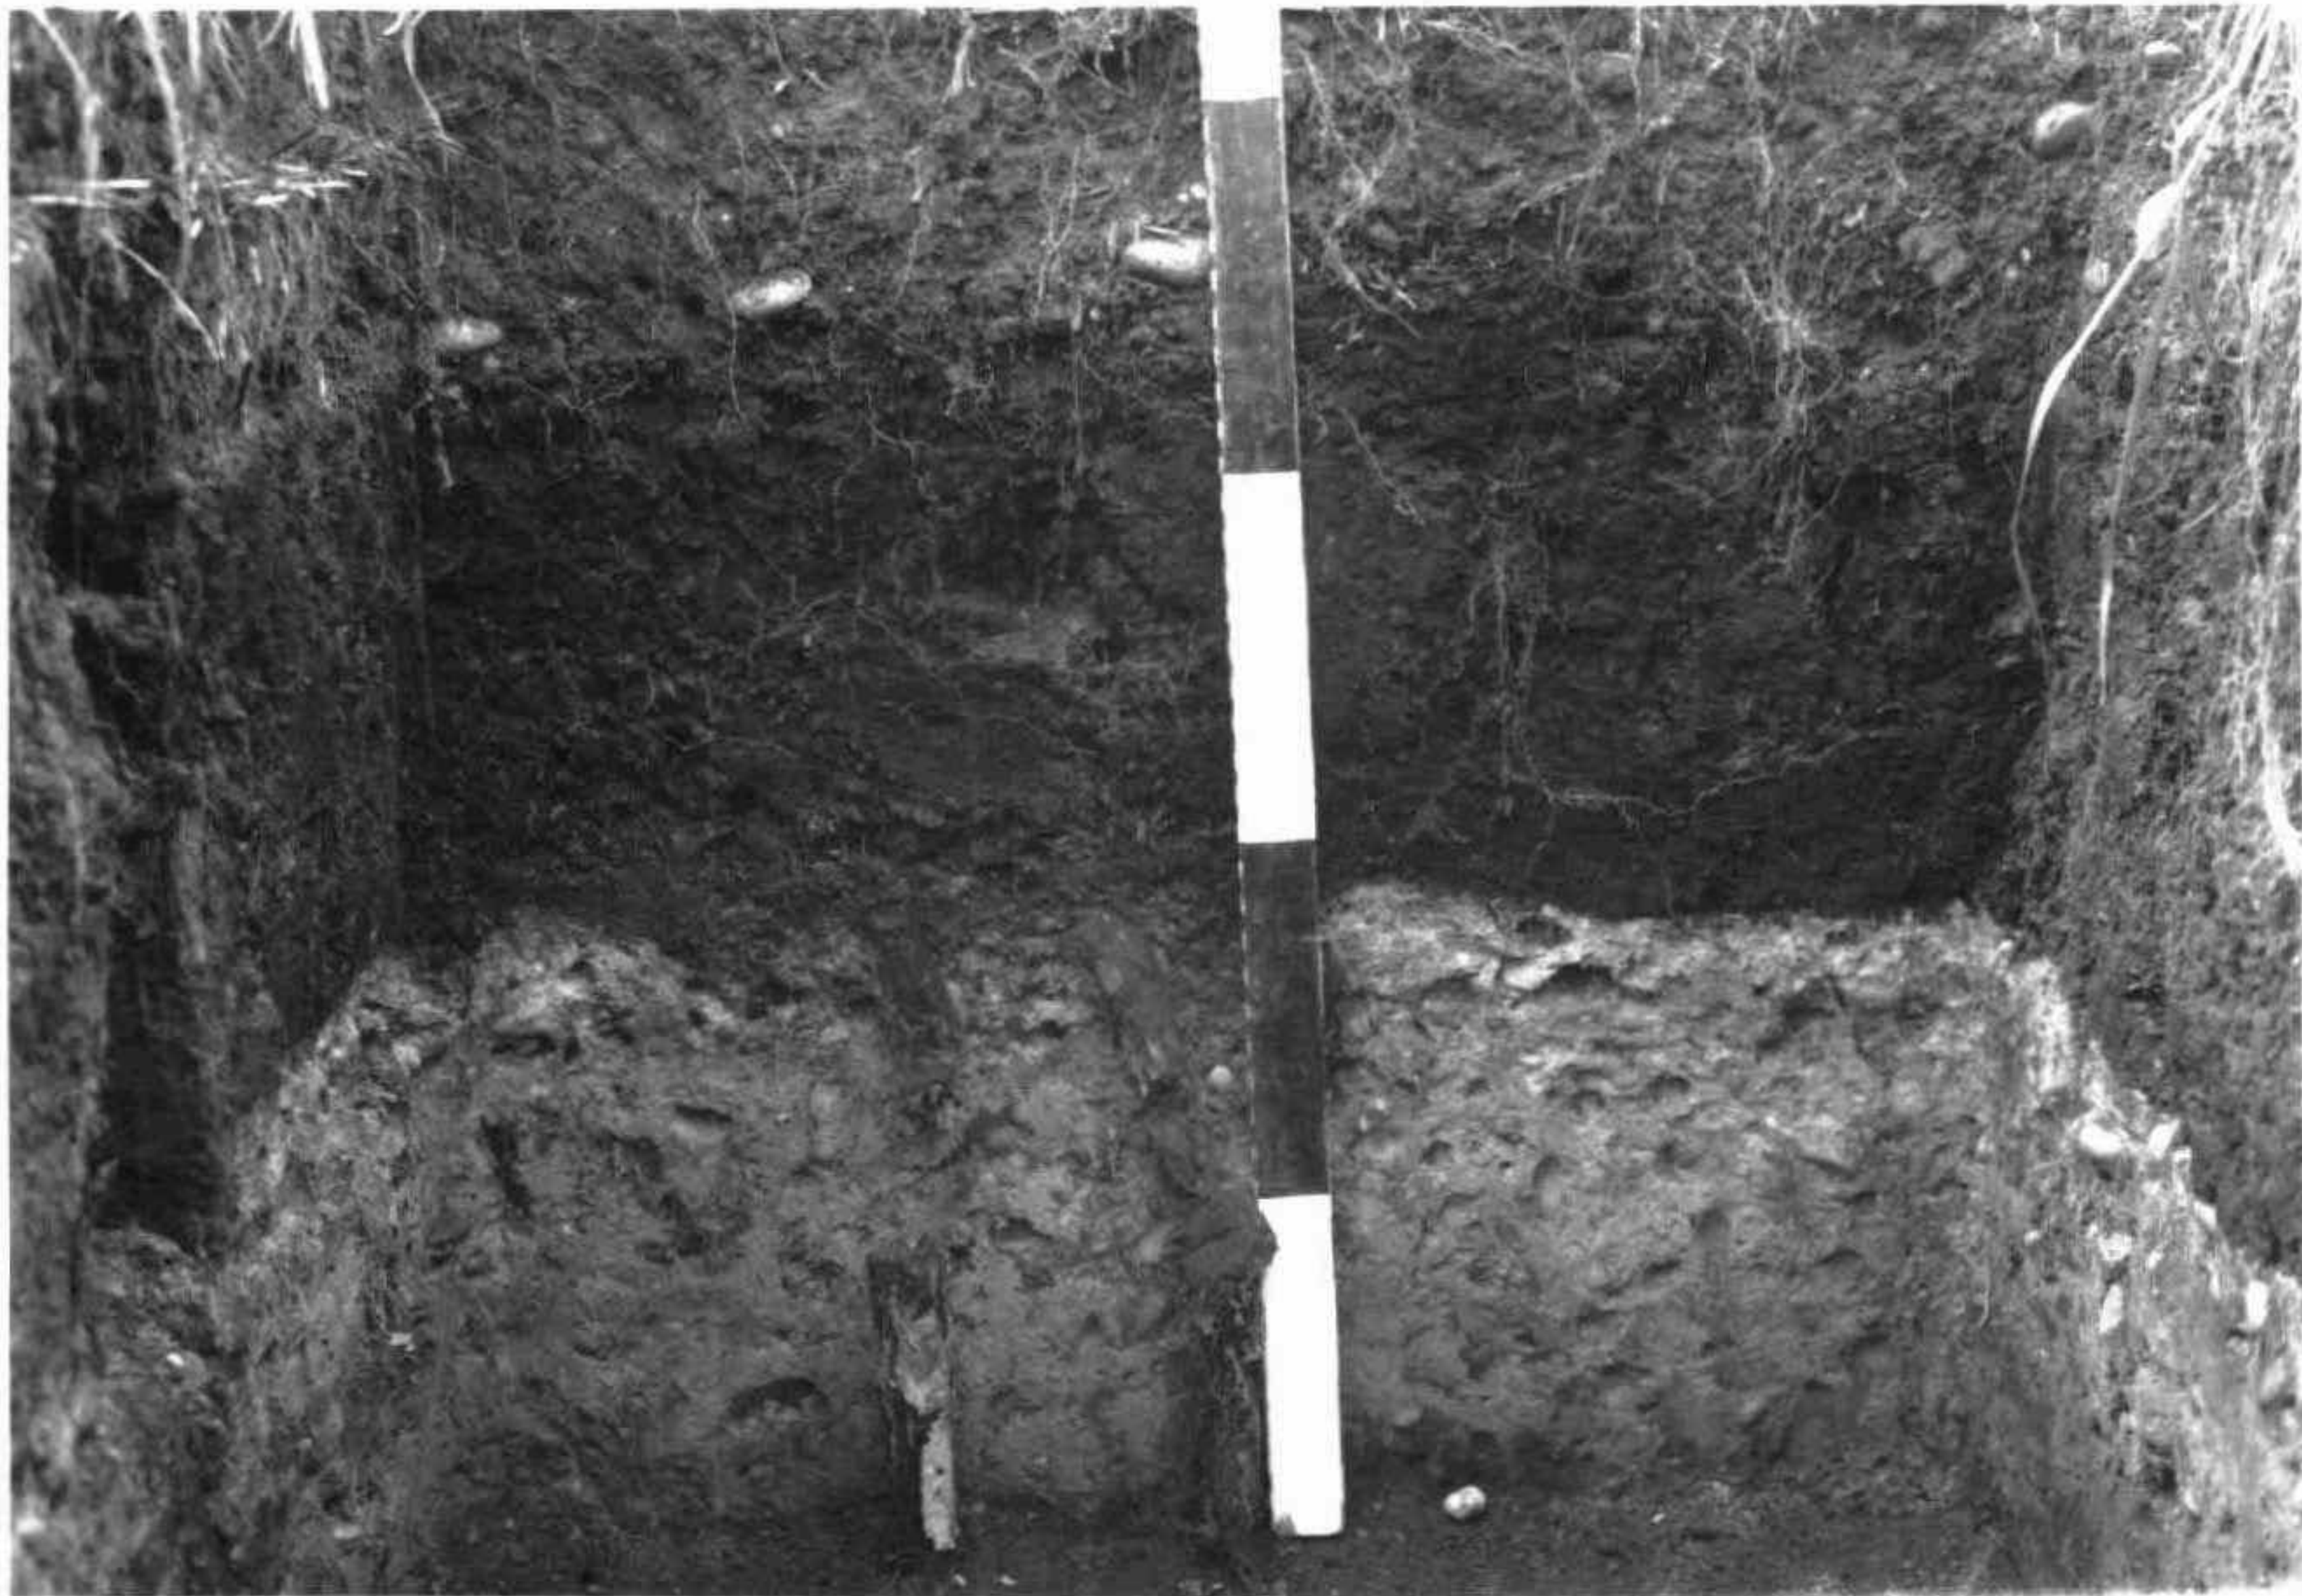
⑥

- 6 South section of the trench showing the post-Roman peat (with roots penetrating down from it) and the metalling/road make up. Scale in 25cm divisions.
